Structural and Mechanical Inspection Report

Prepared for Codie & Will Crenshaw
Concerning 2606 Tip Cove
Austin, Texas

Concerning: 2606 Tip Cove, Austin, TX -
(Address of Inspected Property)

By: Kenneth L Altes, #Professional #623 03/14/2007
(Name and License Number of Inspector) (Date)

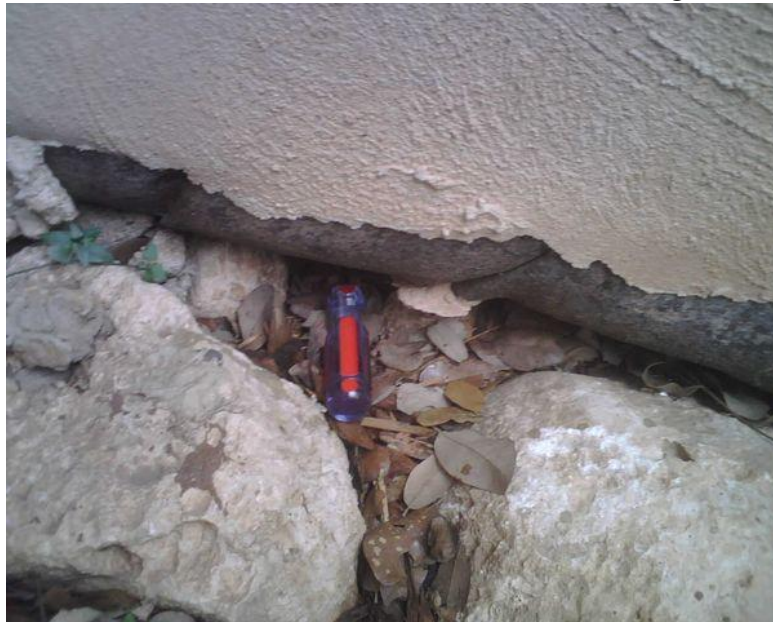
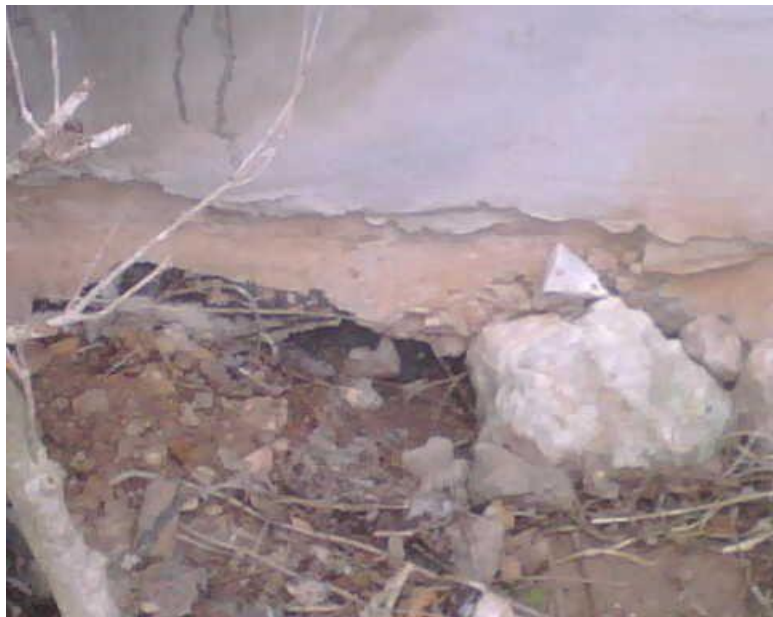
A. Foundations (If all crawl space areas are not inspected, provide an explanation.)

Slab-on-grade type.

No signs of movement, but the rear edges of the foundation do not go into the soil. Recommend that a structural engineer be consulted.

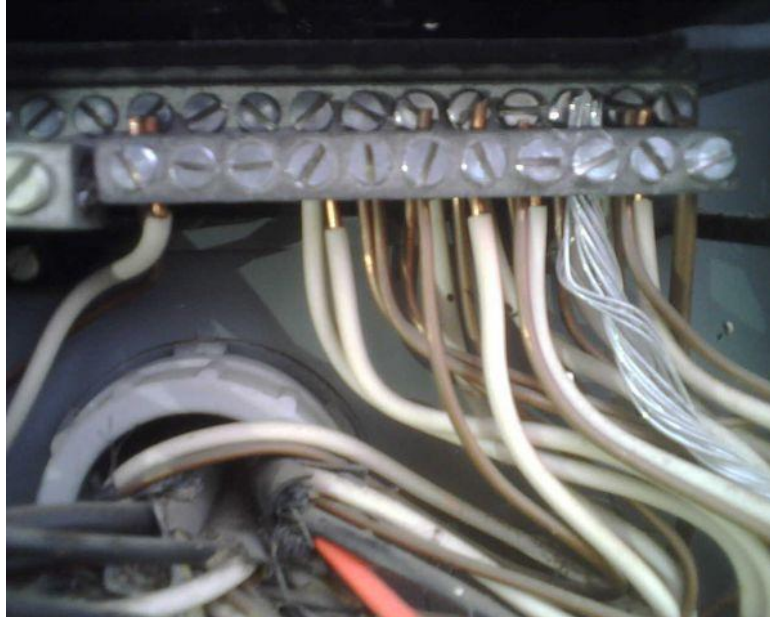
A. Service Entrance and Panels

Neutrals and grounds under one screw.

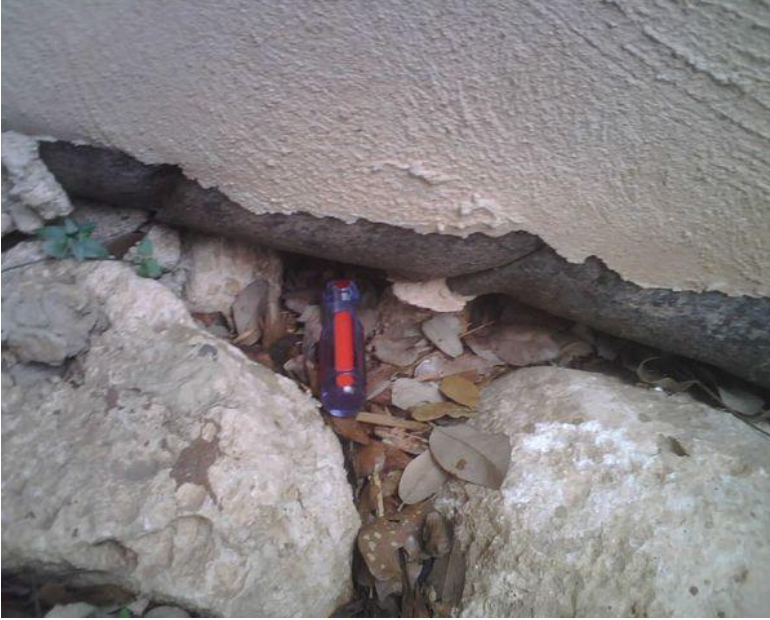
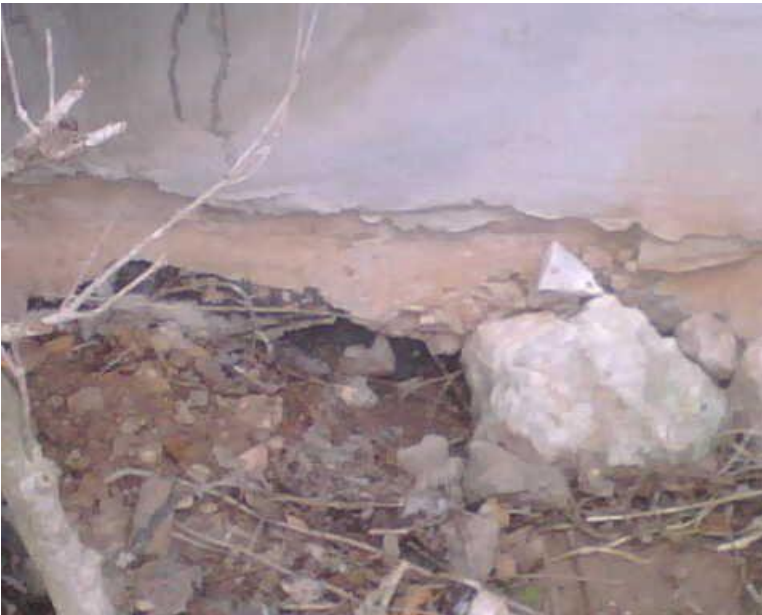
Foundations

Slab-on-grade type.

No signs of movement, but the rear edges of the foundation do not go into the soil. Recommend that a structural engineer be consulted.

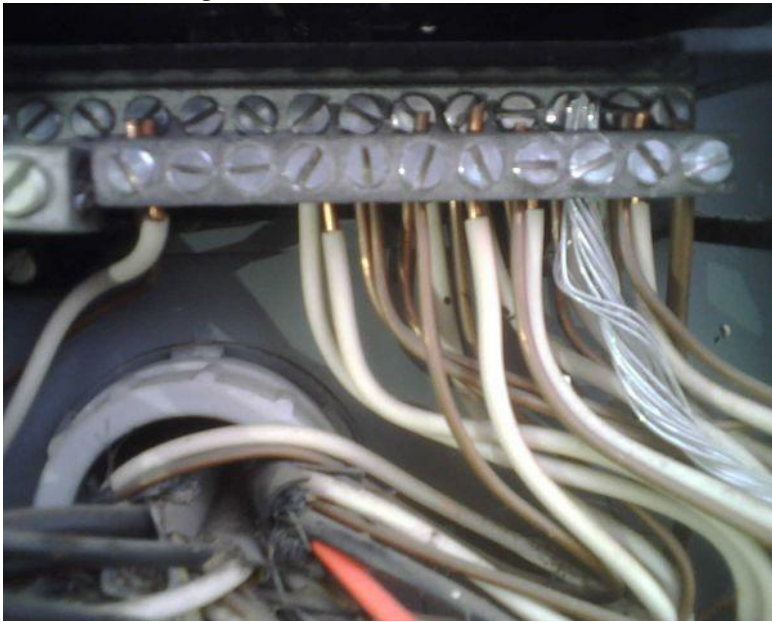
Electrical Service Entrance and Panels

Neutrals and grounds under one screw.
